ETDL5

FOR REFUSE DUMP OPERATION

LOADER

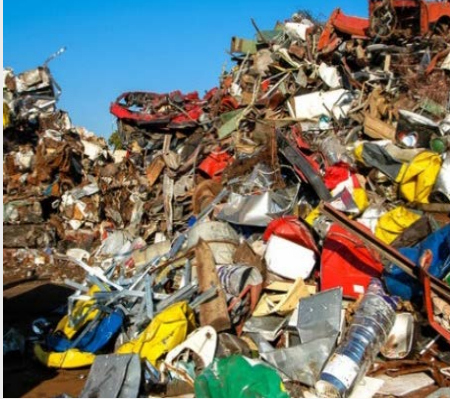
Sharp and Hard Objects

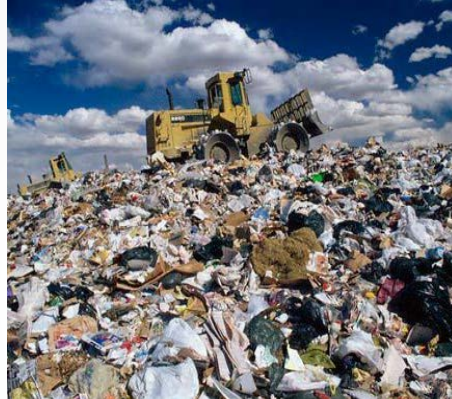
High Loading

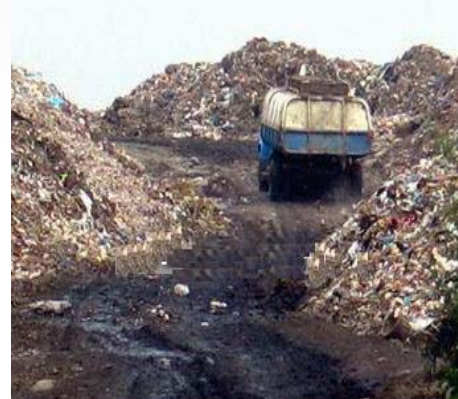
Tough and Complicated
Road Condition

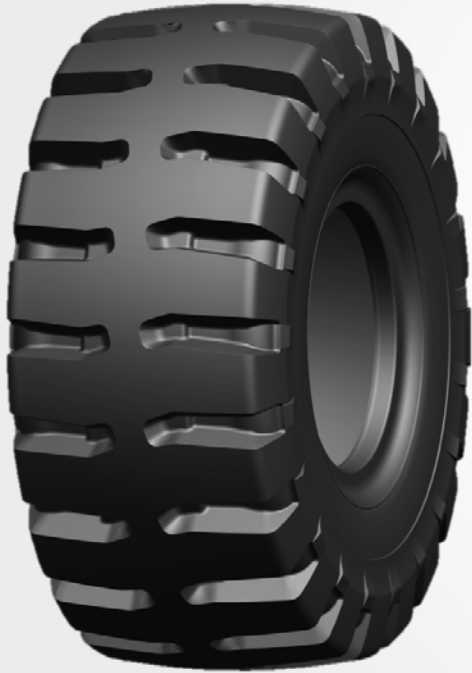
ETDL5

Excellent puncture resistance performance

- Deeper OTD Design

Heavy load capacity

- Strengthen Structure Design

Better impact resistance performance

- Armor Sidewall Design

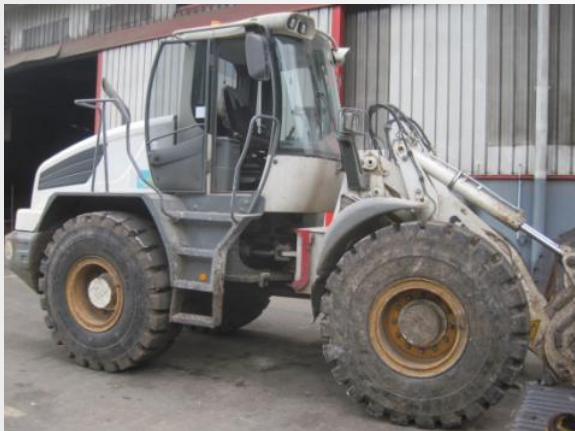
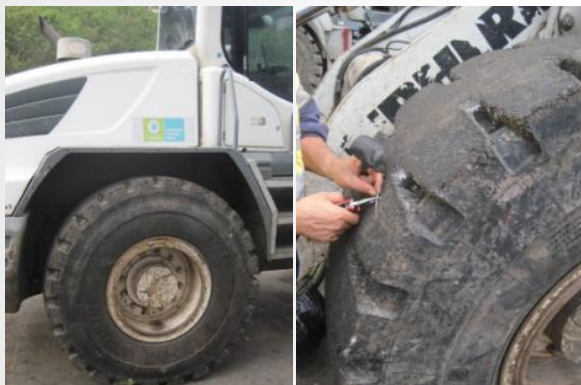
• Field Report from Garbage Disposal Plant New Caledonia

General Information	
Vehicle Name	LIEBHERR 538
Tire Size & Pattern	20.5R25 ETDL5
Original Tread Depth	76 mm
Average Total Working Hours	4,000+ hrs
Site Category	Garbage disposal plant
Working Condition	Acidic, many nails
Country	New Caledonia

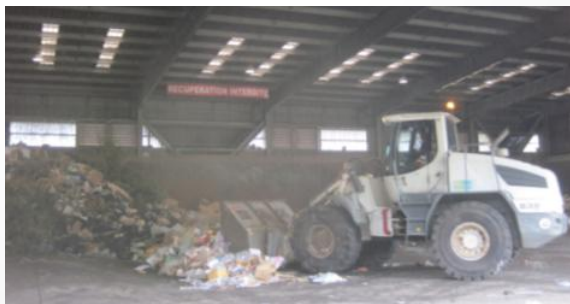
The average tire life of Brand B is 2500~3000 hrs.
